## **Stream Channel Stability and Channel Evolution in a Rapidly Urbanizing, Ridge-and-Valley Watershed, Beaver Creek, Knox County, Tennessee**

Francis Bartholomew Keaney  
*University of Tennessee - Knoxville*

Keaney, Francis Bartholomew, "Stream Channel Stability and Channel Evolution in a Rapidly Urbanizing, Ridge-and-Valley Watershed, Beaver Creek, Knox County, Tennessee. " Master's Thesis, University of Tennessee, 2009.

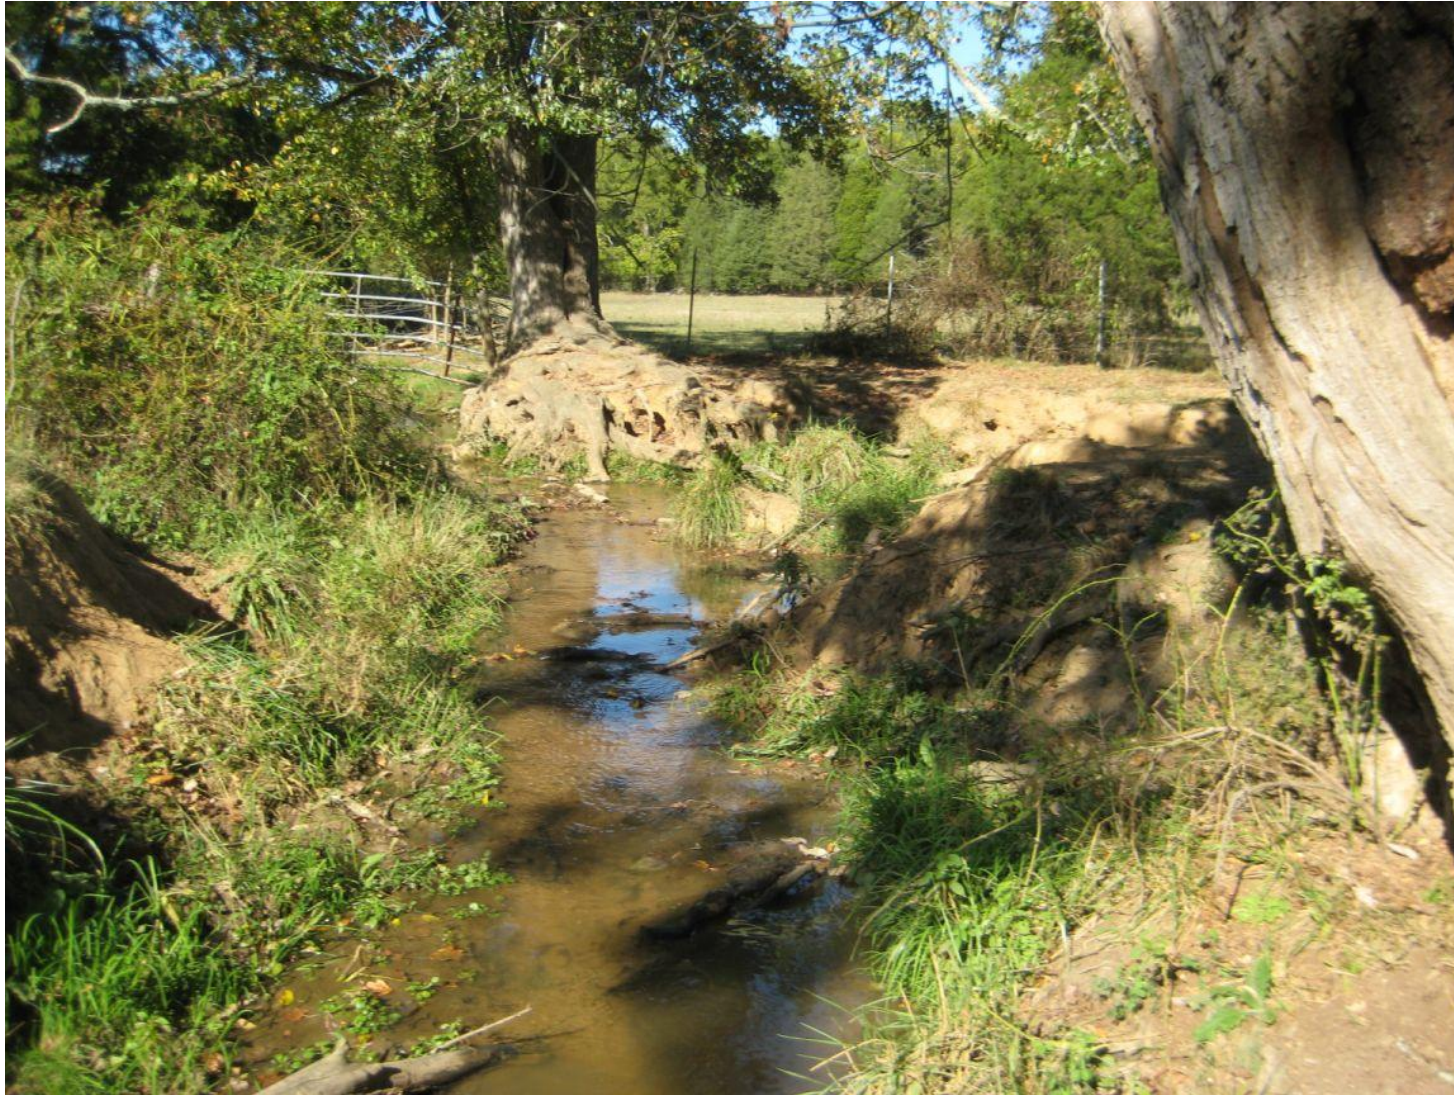
Figure 19 - Lammie Branch, Site 13, Channel Stability Index: 28.5

aggrading material led to the high RGA score. Restricted access to the stream prevented an investigation of the condition of the channel between these sites, but their disparate nature reinforces the variability in watersheds that are affected by development.

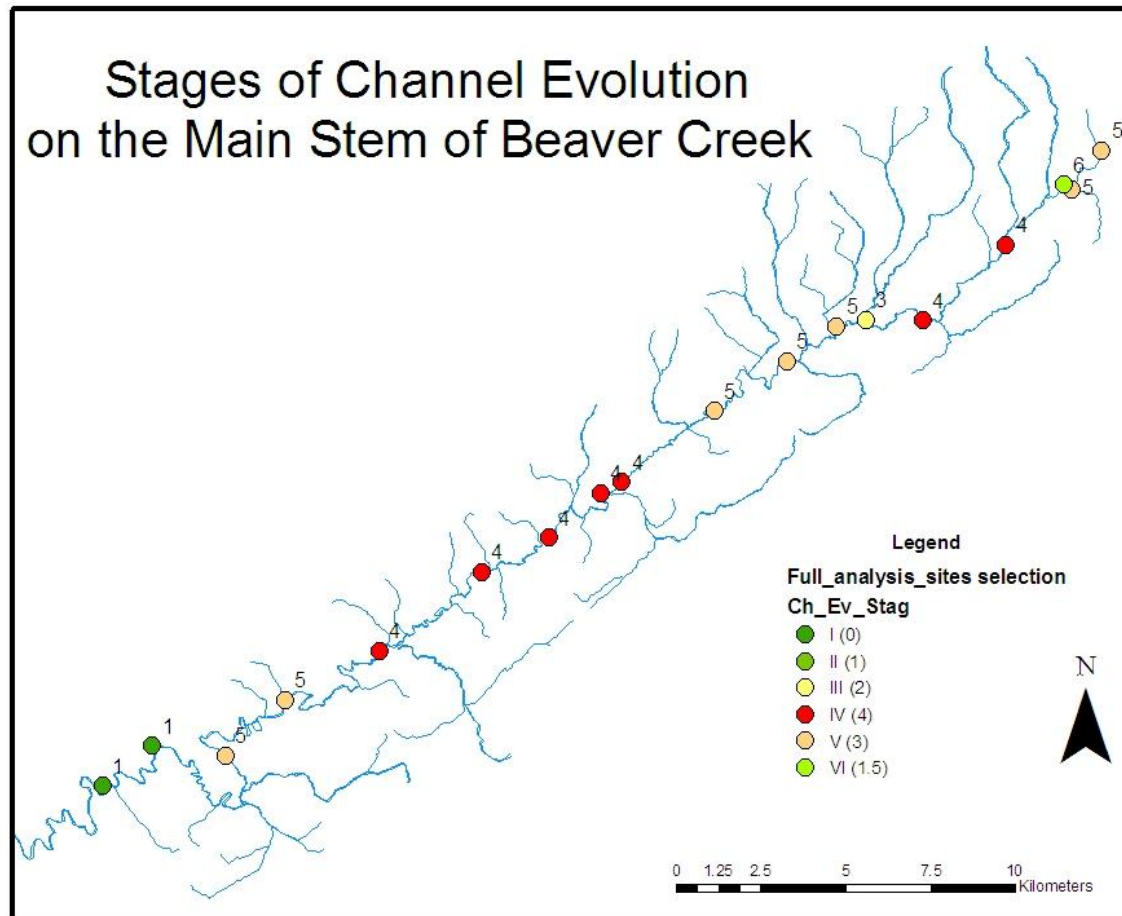
Figure 20 - Stages of Channel Evolution on the Main Stem of Beaver Creek

None of the stream channels in the sub-watersheds in the Beaver Creek watershed showed discernable patterns in the stages of channel evolution observed along their courses of flow. The main stem of Beaver Creek did appear to show a pattern of adjustment, which was similar to that reported in Simon and Rinaldi (2000) for West Tarkio Creek, a stream of similar length to Beaver Creek, and along which a similar number of sites were evaluated (Figure 26).

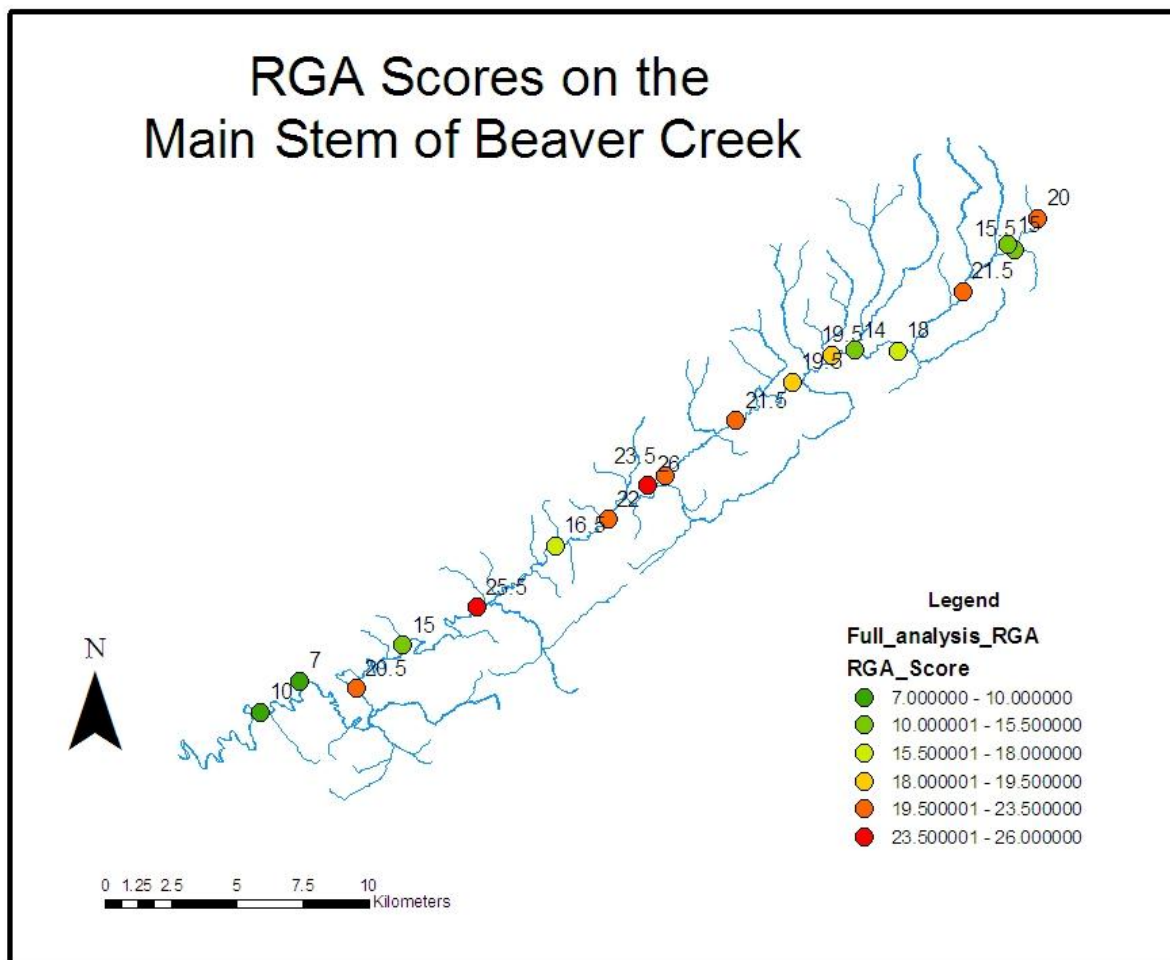
Figure 21 - RGA Scores on the Main Stem of Beaver Creek

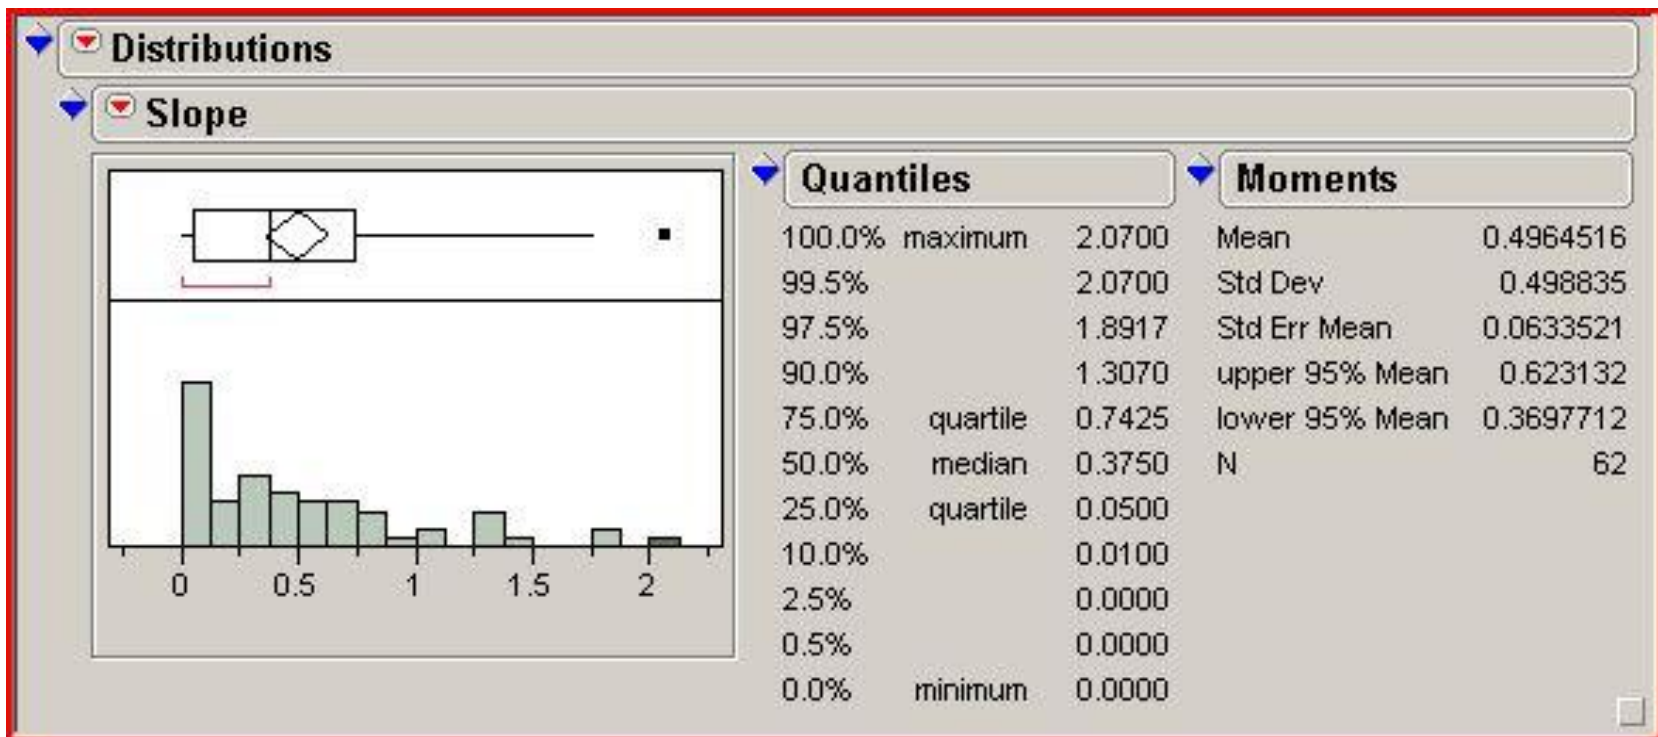
Figure 22 - Distribution of Slope Values in Percent

expected relationship that was not apparent in the data was an influence of slope on channel incision ( $r = 0.0932$ ,  $P = 0.4903$ , see Fig 18). Based on the unit stream power relationship, it was expected that as slopes increased, more erosive energy would be present and more bed material would be removed. Since there was no evident relationship between slope, incision, bed material size or stability, as shown in Figure 25, this did not appear to be the case in this watershed. It should be noted again that since almost 85% of the observed slopes were below a 1% grade, there was little variation in the sample.

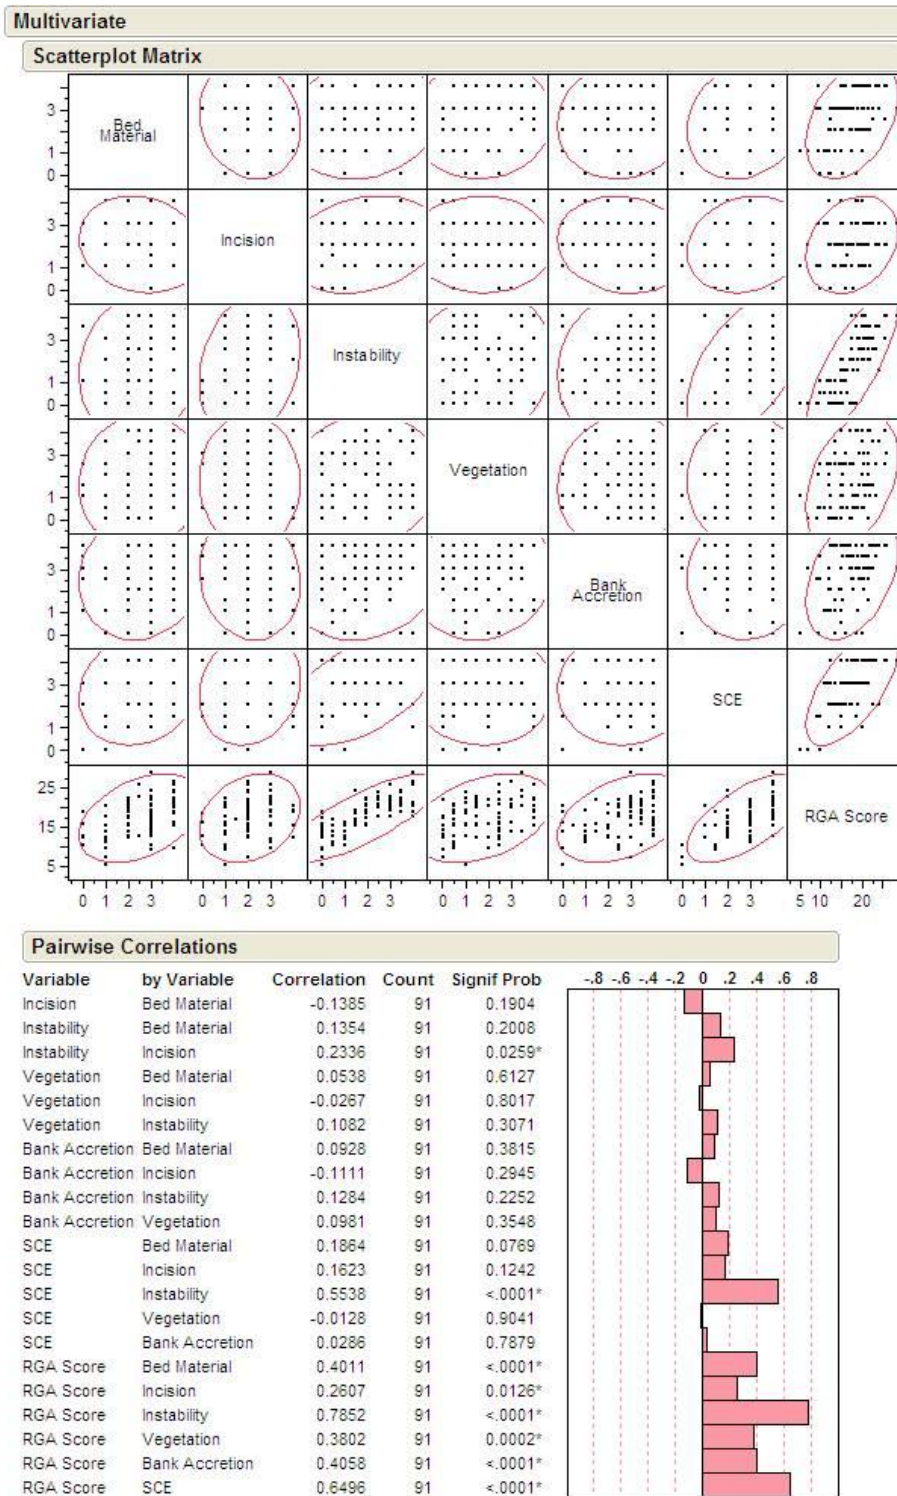
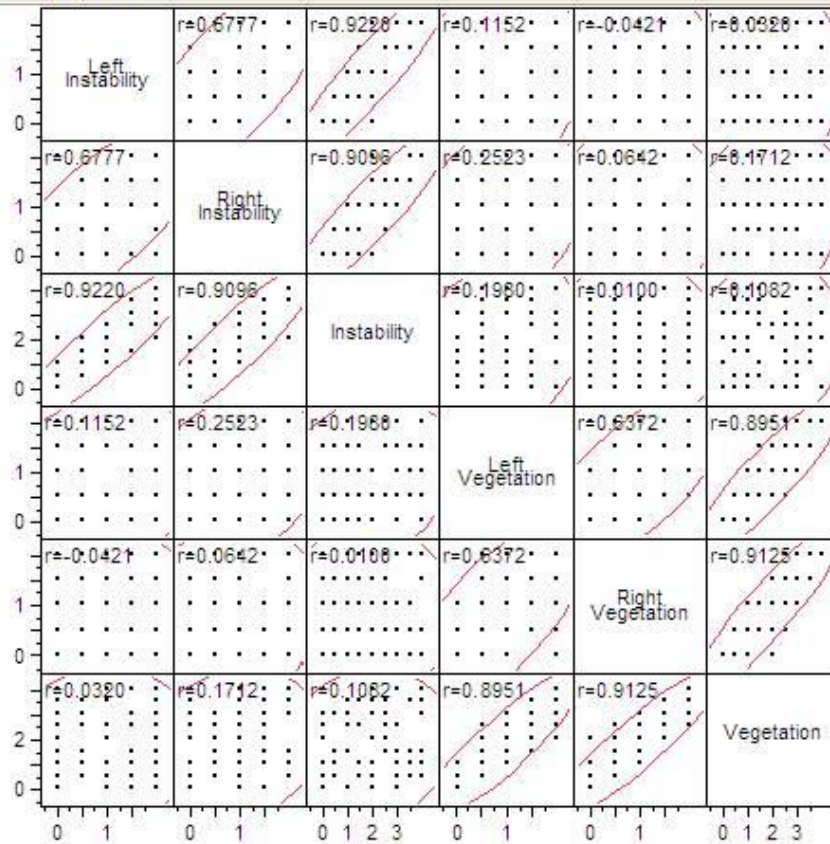
Figure 23 - Scatterplot Matrix and Pairwise Correlation Analysis of RGA Variables collected at All RGA Sites

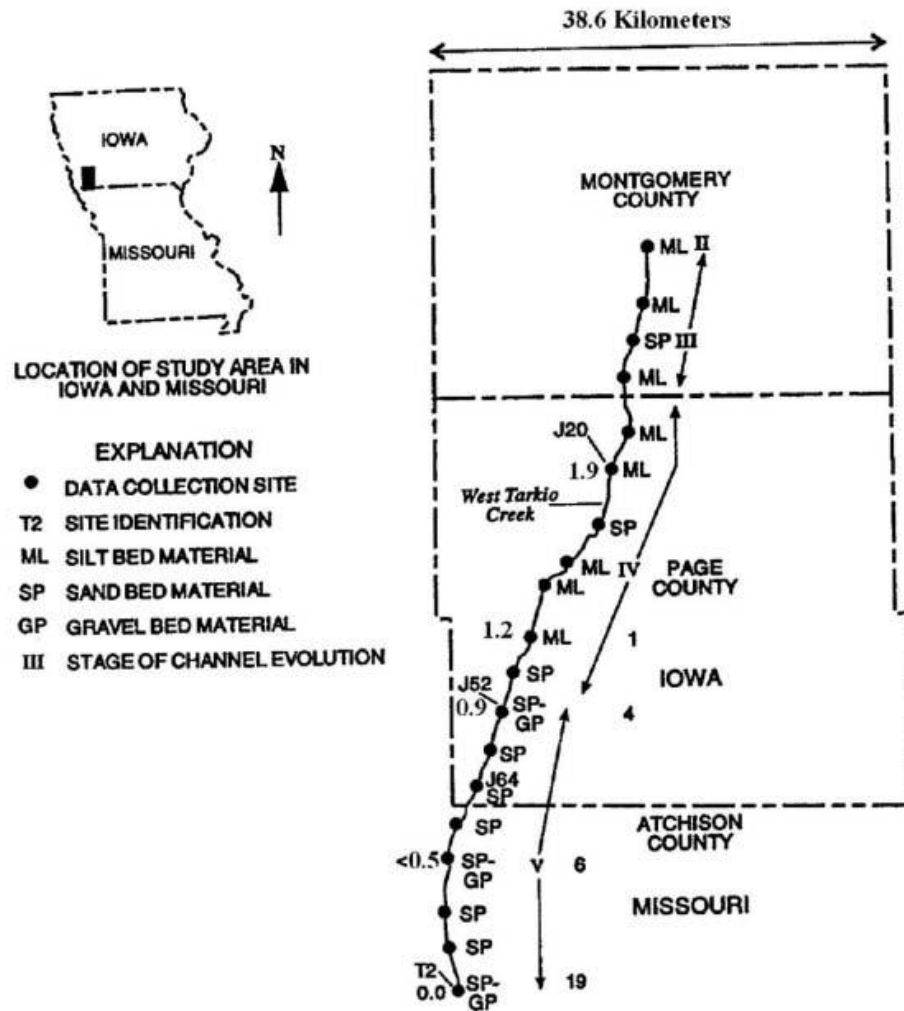
Fig. 9. Map of West Tarkio Creek showing stages of channel evolution, dominant bed-material size class, age of oldest riparian tree (years, numbers on right) and widening rate (m/y, numbers on left). Note systematic trends of stage of channel evolution, rates of widening and age of oldest riparian species with distance upstream (from Simon and Rinaldi, 2000).

Figure 26 - Map of West Tarkio Creek (Simon and Rinaldi, 2000)
